The Palms Shopping Centre »

CHRISTCHURCH: Restoring a Ravaged City

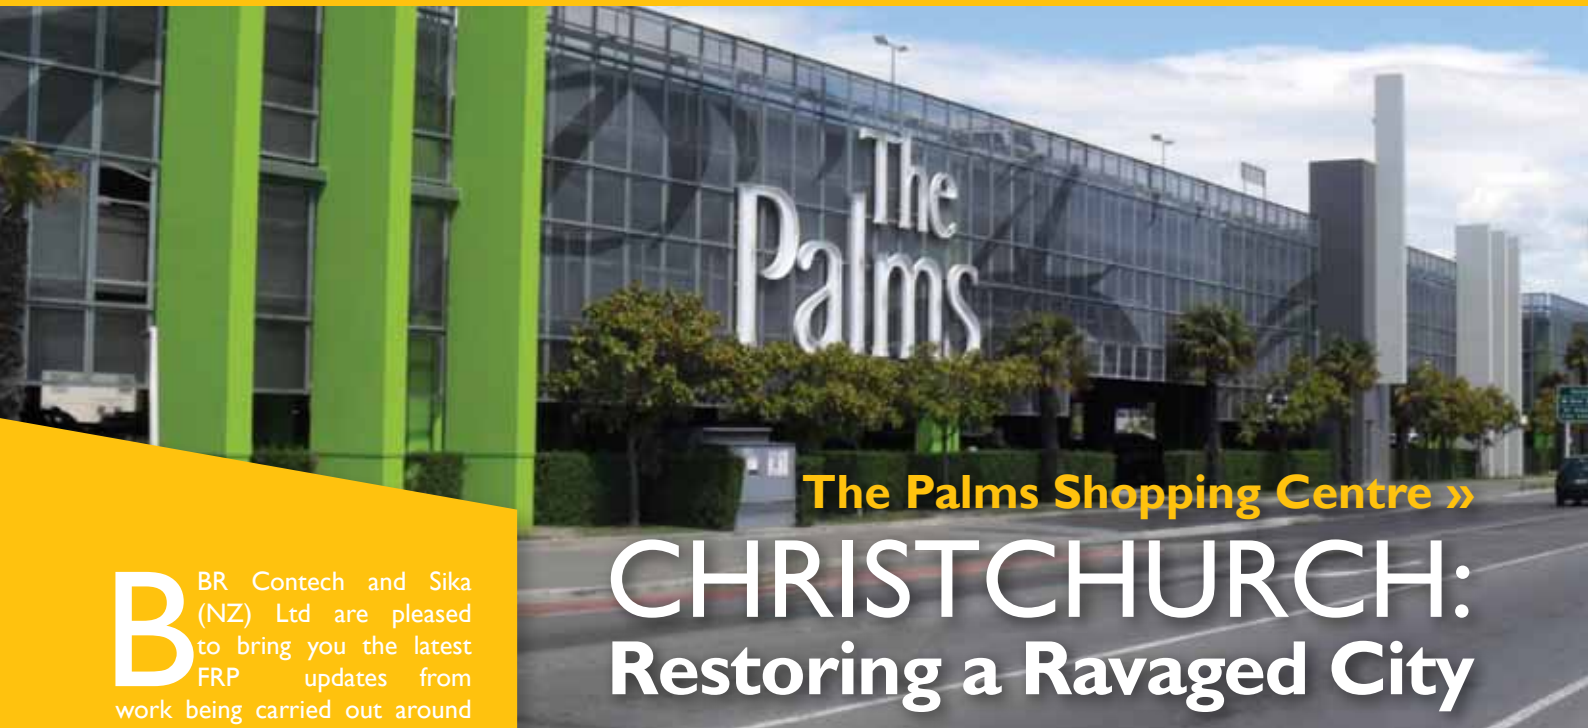
A popular shopping centre badly damaged in the 2011 Christchurch earthquakes is now in great shape after a comprehensive repair and strengthening project.

With damage in the 6.3-magnitude earthquakes in February and June 2011, The Palms was forced to close for more than six months for a \$20 million restoration project. BBR Contech was one of the companies engaged to undertake FRP related work - repairing and reinstating more than 250 damaged concrete beams and columns in both the shopping centre and its associated car-parking areas.

Working with main contractor Naylor Love and designers Buller George Turkington, BBR Contech repaired the columns by breaking out loose and spalled concrete and replacing it with Sika MonoTop Micro-Concrete, then wrapping the columns with SikaWrap carbon fibre. Any cracks identified in precast beams and carpark stairwells were repaired using Sikadur-52 epoxy resin.

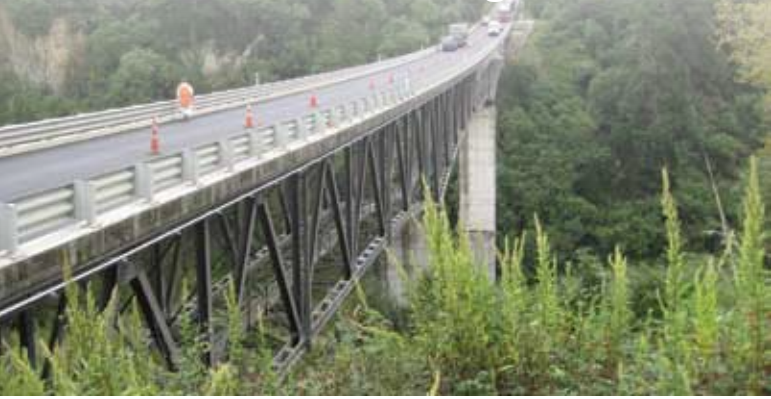
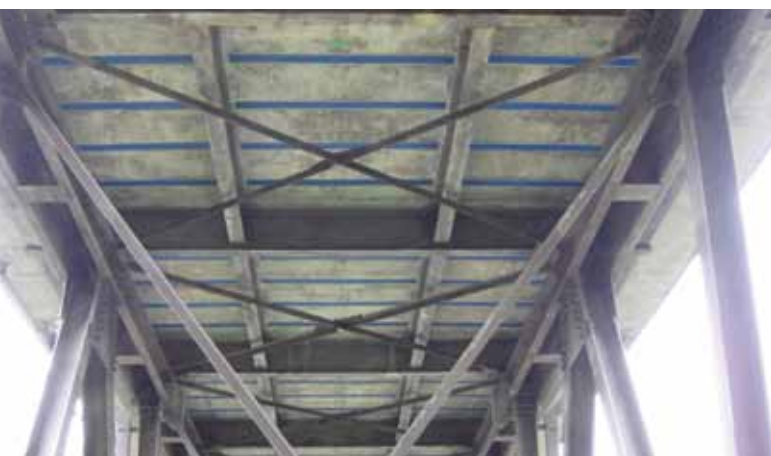
Built in 1962, the two-lane, steel-trussed Mohaka River Bridge is located in an isolated area along the Napier-Taupo Road (State Highway 5). Elevated 50 metres above water level on two reinforced-concrete piers, it stretches 215 metres across the river – providing a vital thoroughfare for freight and passenger traffic throughout the year.

Having undergone seismic strengthening in 2009, the bridge's concrete deck now requires FRP strengthening to cope with allowable heavier traffic loads. Working for main contractor Fulton Hogan, BBR Contech is responsible for three key components of work on the underside of the deck: injecting flexible sealant into more than 1200 metres of cracks in the structure; applying 740 strips of 1.85-metre-long Sika CarboDur to the concrete surface; and finally applying a corrosion-inhibiting coating to give extra protection against the elements.

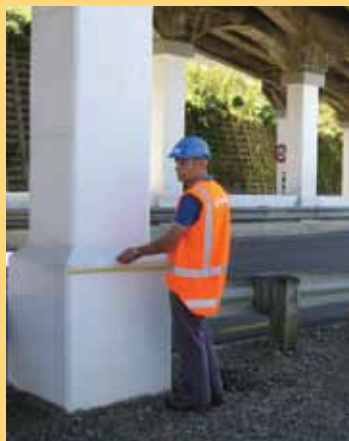
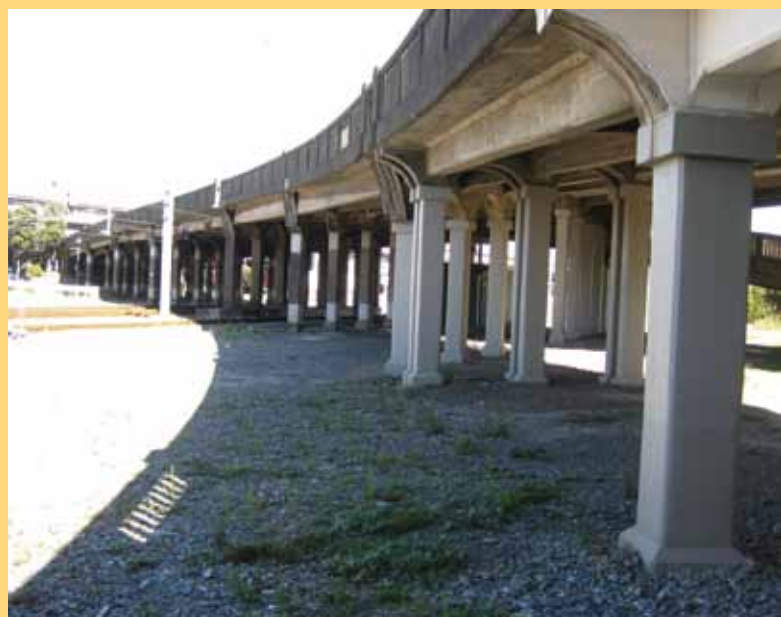
Aotea Quay Overbridge, Wellington »

In 1996, Wellington's Aotea Quay Overbridge became the first bridge in New Zealand to be seismically strengthened with FRP composite materials. In 2011 – and after 15 years of rugged performance in a corrosion-prone coastal environment – Wellington City Council commissioned BBR Contech to undertake further structural strengthening as part of a comprehensive repair and maintenance programme.

In the three-month project, BBR Contech repaired and strengthened an additional 65 columns, applying one layer of SikaWrap-930G followed by a coating of crack-bridging paint to provide essential protection against the elements. Checks of the FRP jackets installed in 1996 revealed they were still in good shape, providing confidence that this was a high performing and effective long-term total solution.

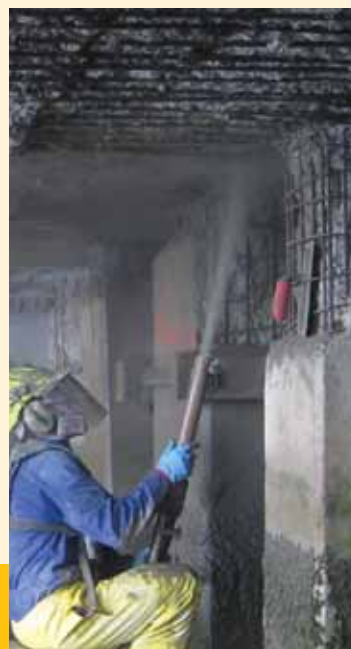
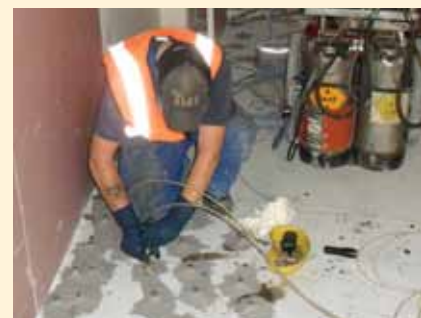
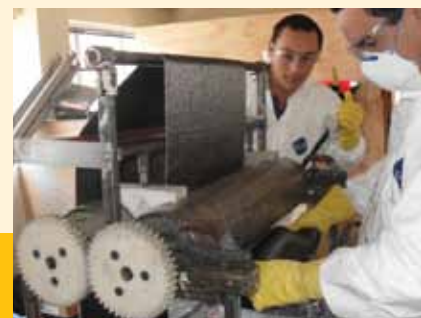
The work following the Christchurch earthquake events has involved a large range of repair and strengthening techniques. The specific nature of any work will depend on the form of the structure, degree of damage and structural deficiency and what materials were used in the original construction. There are always some additional considerations when dealing with an historic or heritage structure. Typical techniques include crack injection, patch repairs, sprayed concrete and the application of FRP.

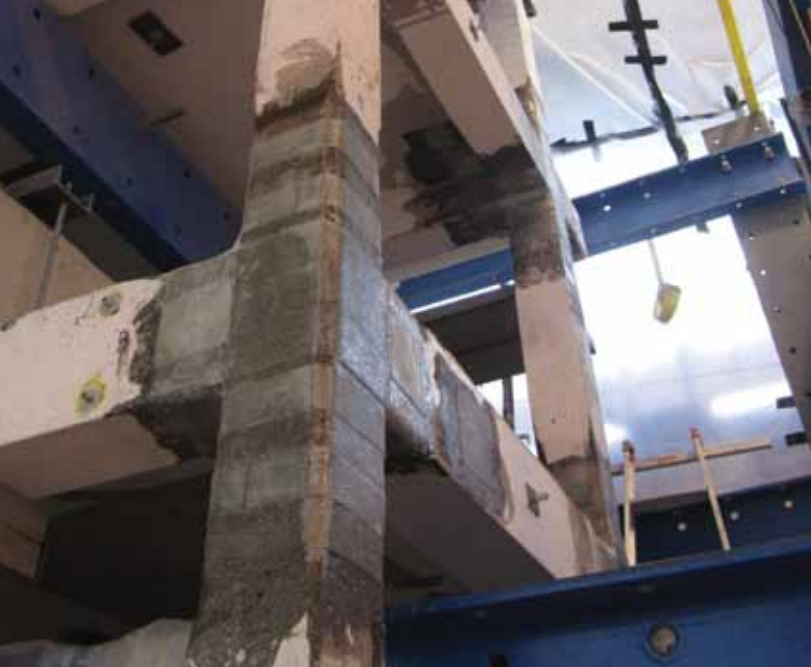
Pre-earthquake FRP strengthening has proved its worth for several Canterbury buildings including the University of Canterbury's Student Services Building.

Just five days before the September 2010 earthquake, BBR Contech completed strengthening 23 circular columns on the building. This involved exposing the concrete substrate on the columns, then applying two layers of SikaWrap-100G glass fibre in 600-millimetre-wide bands at the tops and bottoms. A post-earthquake inspection revealed that, despite new cracks beneath it, the glass fibre (and column) remained intact – exactly as intended.
